**2013** | Environmental Report

# The environmental management system and the good practices

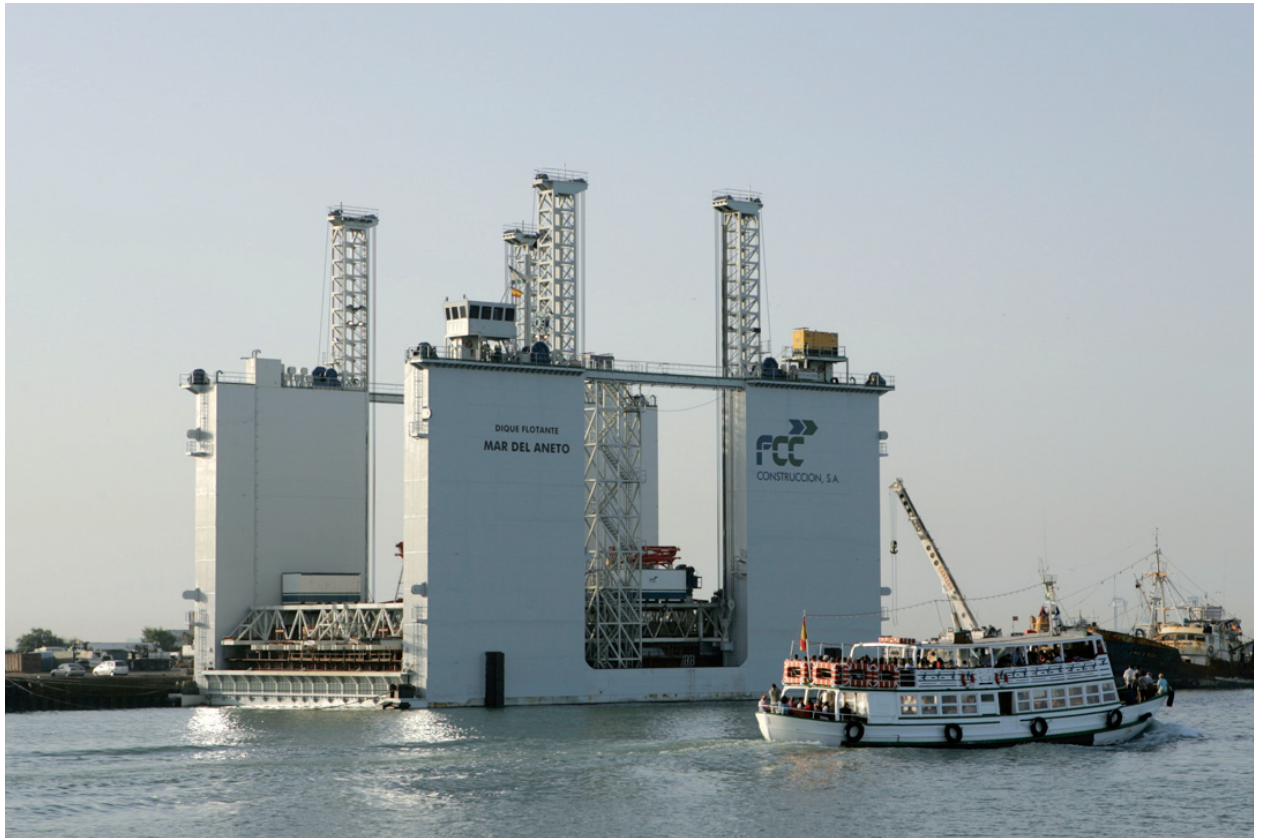
► Caisson structure built by FCC Construcción at Dock 4, Rota Naval Base.

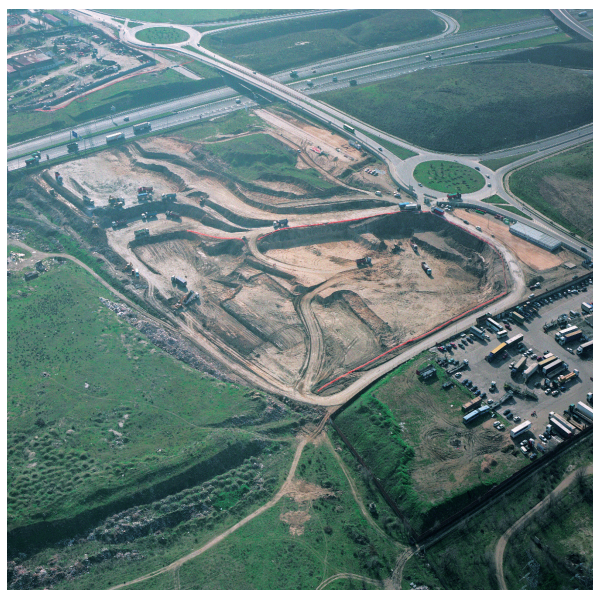
> Works undertaken, in order to prevent the construction impact of the project storm water tank of Butarque.

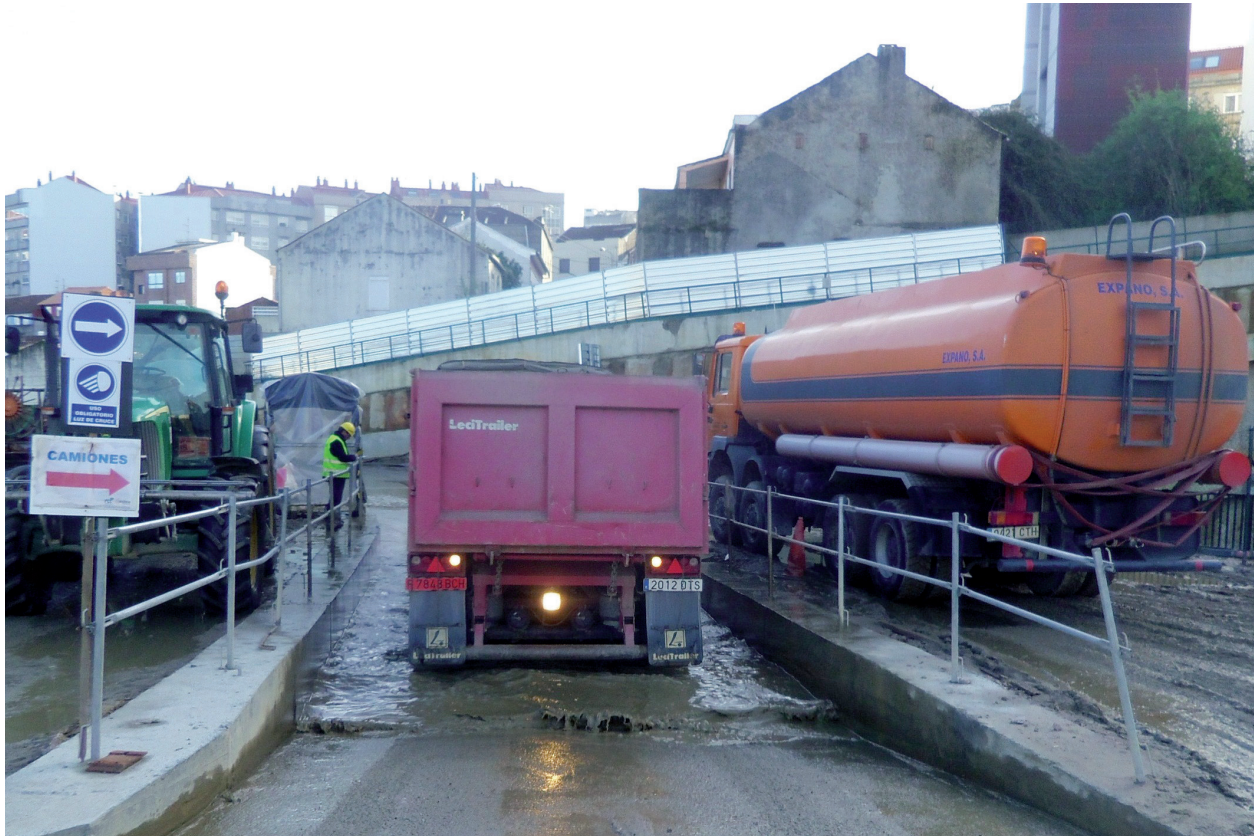
➤ Washing the wheels of trucks before they reach the public highway prevents mud and dust from being deposited, which is especially important when the site is located in an urban area.

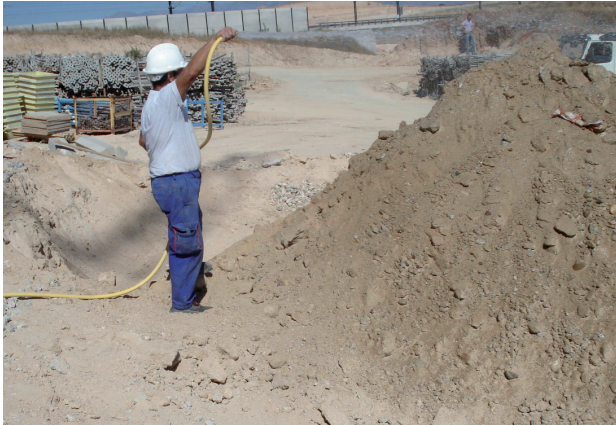
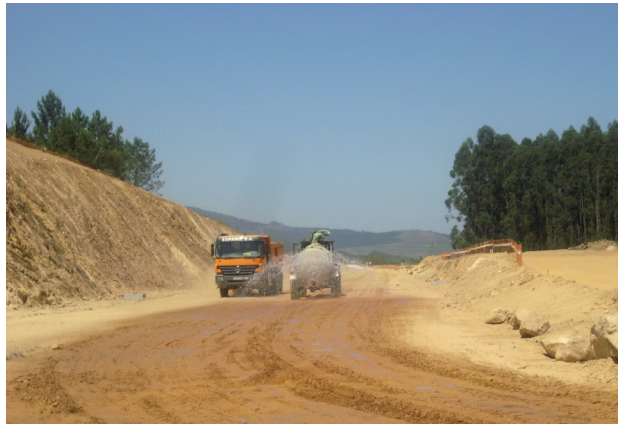
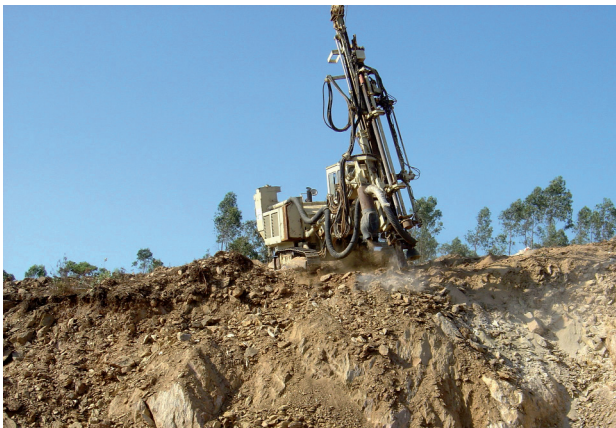
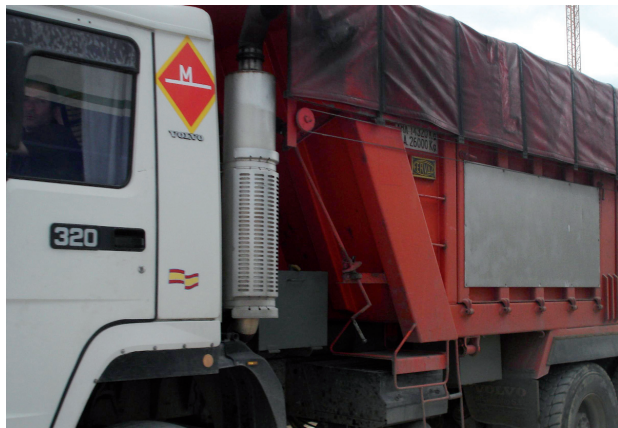
➤ Reducing dust is one of the top priorities on all of our sites. Among the Good Practices that are generally implemented is the watering of tracks and stockpiles, the covering of trucks and the use of machinery with dust capture systems.

These results enable us to conclude that transportation is the main source of dust, followed by earth moving and demolitions. Washing with water is an efficient measure for minimising the production of dust, although it entails higher water consumption, an aspect which is included as among the most important elsewhere in this report. In addition, FCC Construcción implements in its works other measures such as using additives in water used for washing to create a surface crust of dust particles. The improvement of the conditions of the road surfaces on which vehicles run by resurfacing with asphalt and compacting, and the restriction of areas for vehicular traffic and speed limits are other good practices that can be complemented with the covering of stored and transported materials and the reduction in the height of dumped materials.

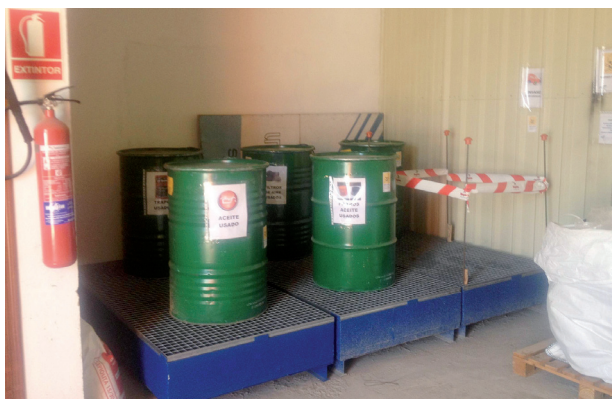
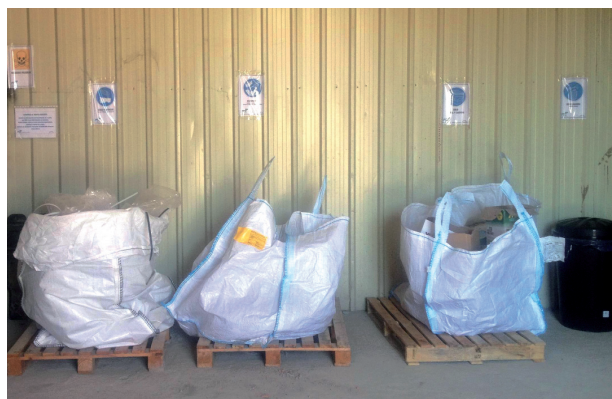
➤ It is vital to know the quantity and type of waste produced by each project so that it can be properly stored and subsequently disposed of. Hazardous wastes must be stored in special areas that are equipped with systems to prevent contamination of land or water in the event of a spill. Good Practices are implemented at all worksites of FCC Construcción, aimed at minimising the production of waste and ensuring that any waste is stored appropriately.

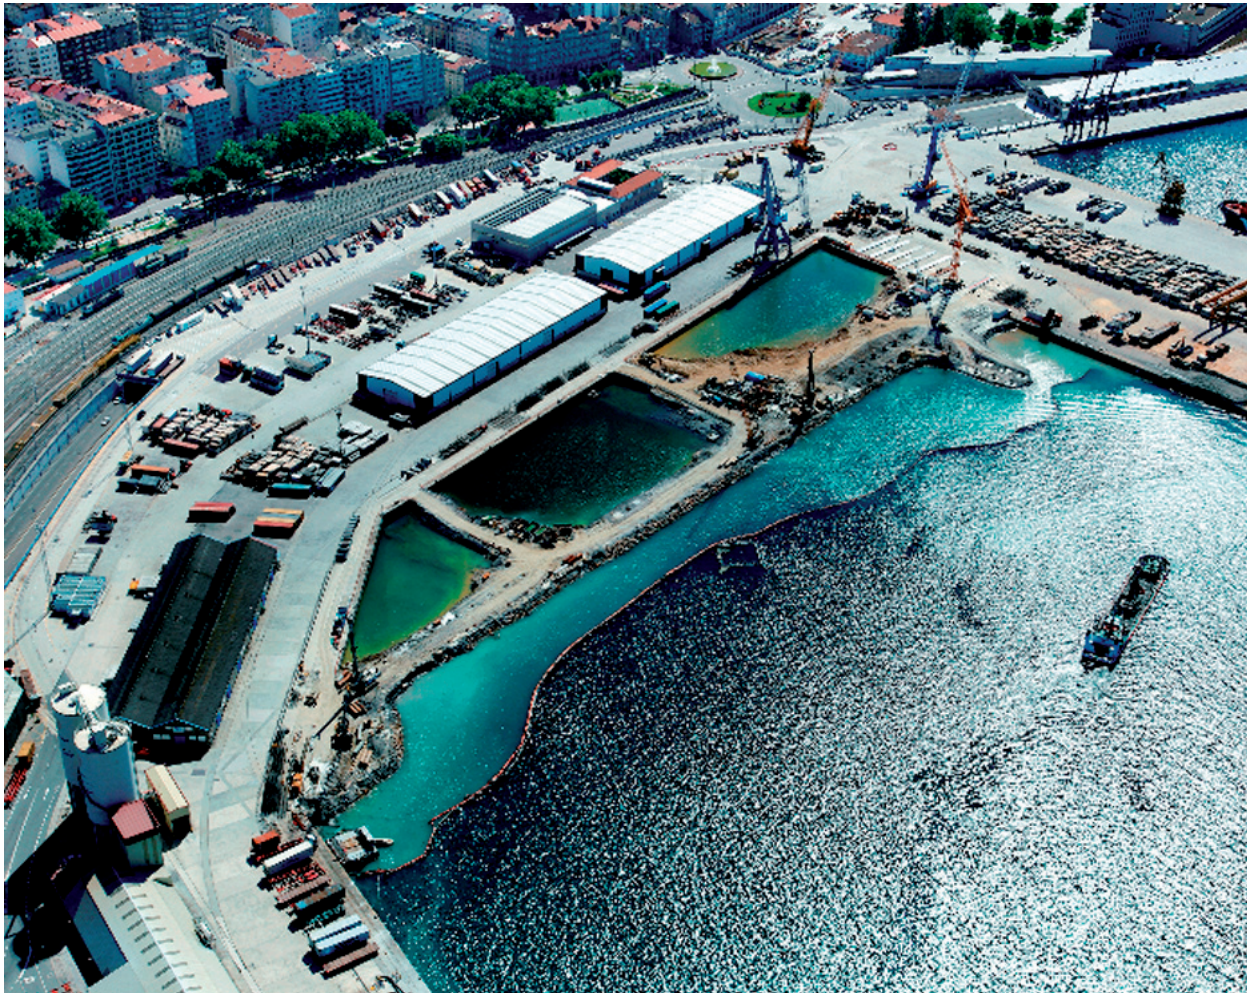
> Anti-turbidity barriers are widely used in projects with dredging or earth moving activities in rivers, lakes or the sea. These ensure that the environment is protected from turbidity caused by sediments.

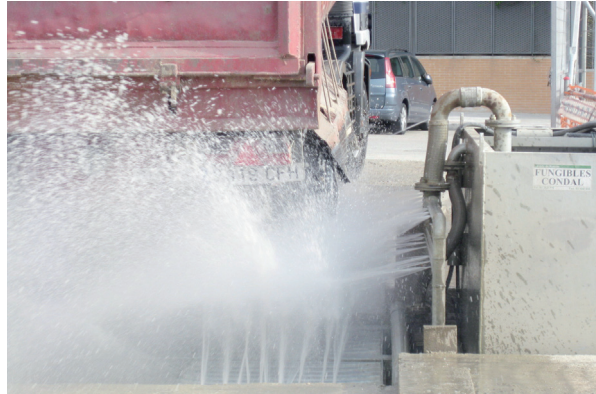
➤ Spraying the wheels of trucks and sweeping the entrance and exit points at sites are simple practices, that are widely used at our sites to prevent fouling the area surrounding the sites.

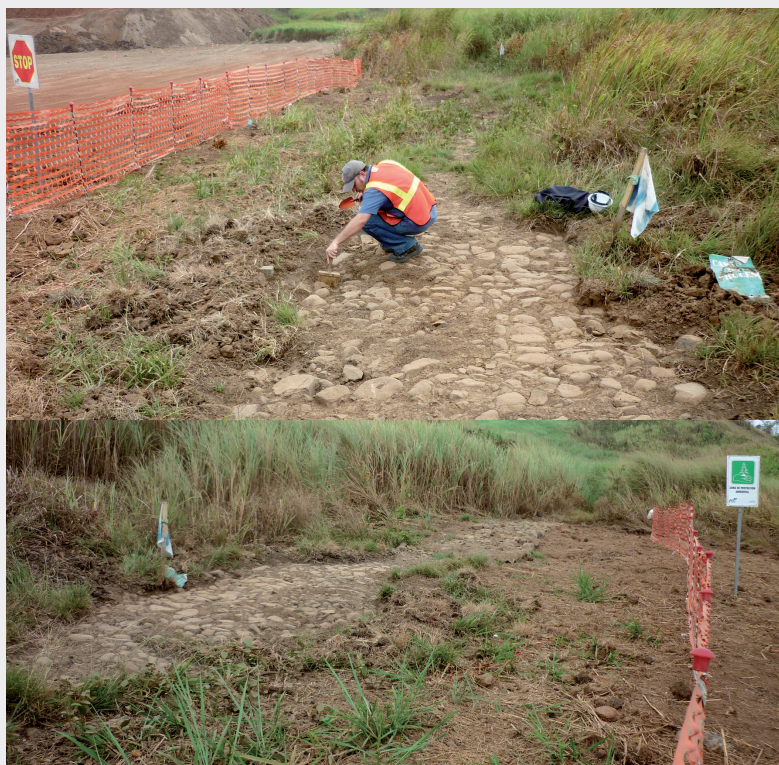
Protection and restoration work on the “Camino de Cruces”.

The measures recommended by the Department of Historical Heritage were adopted, ceding a space of approximately 7 metres on either side of the cobblestone road.

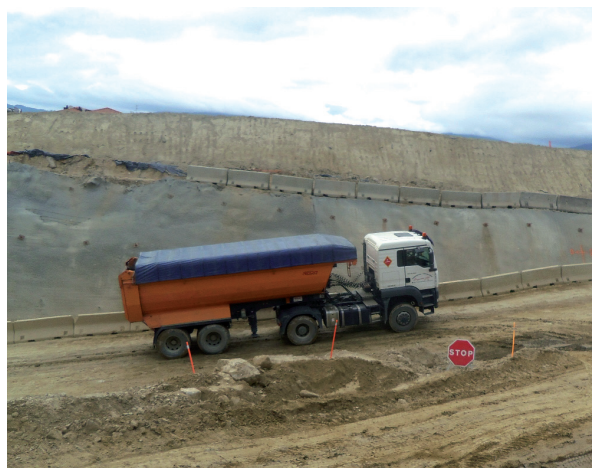
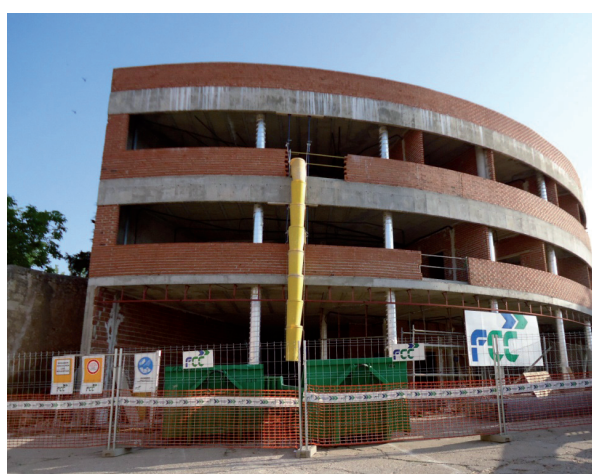
➤ Simple actions that are easy to implement such as covering trucks that transport dust-producing materials or the use of chutes to dispose of rubble from heights considerably reduce the generation of dust on sites.

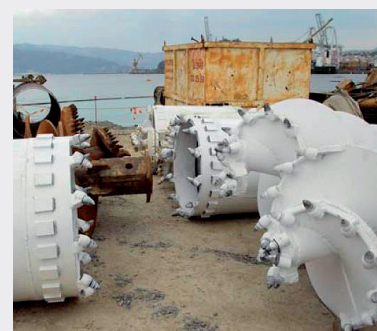
Special tools with widia teeth for rotation drilling of the pile-driving in rock.

- Rotation-drilling rigs with special widia tools for excavation, in order to obviate the need for a vibrohammer, as this tool's blows, fracturing the rock and using a scoop to remove the debris, creates more of a disturbance in terms of noise and vibrations.
- Driving lost casings using a hydraulic variable-frequency vibrohammer, a type of machine that eliminates resonances when it is set in motion and on completion of the job, thereby reducing noise and vibrations to a minimum.

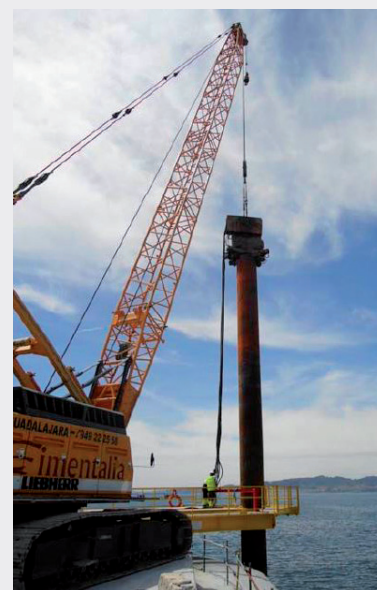
A hydraulic vibrohammer in action driving lost casings.

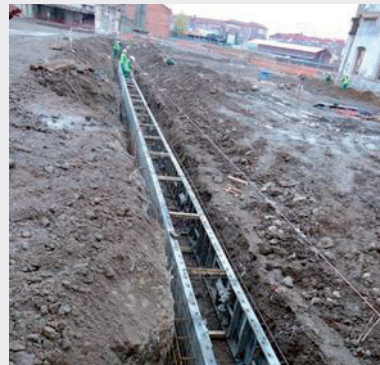
Building the guide wall with formwork on one side.

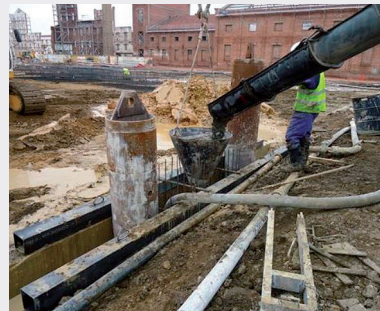
Placing the tubes before concreting the slurry wall.

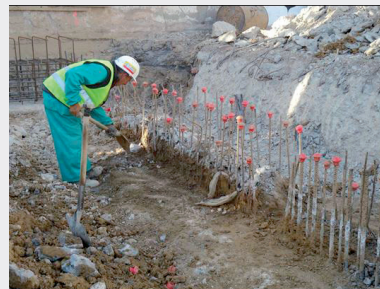
Cleaning the mud mixed with bentonite from the adjacent screen walls.

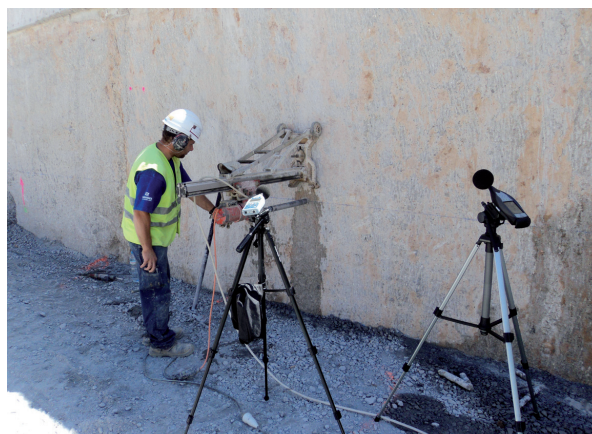
> In those projects in which noise can have impacts on humans or on the environment, noise level measurements help us to take the necessary measures to reduce their generation.

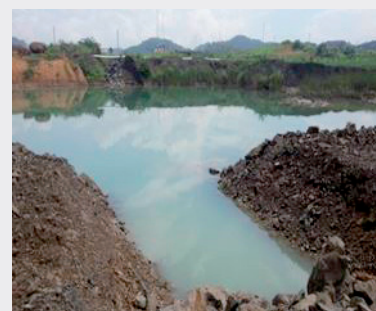
*View of the pool at its maximum pumping level.*

The problem was caused by a flaw in the pool design, as this was not appropriate to ensure the retention time needed to allow the deposits to settle.

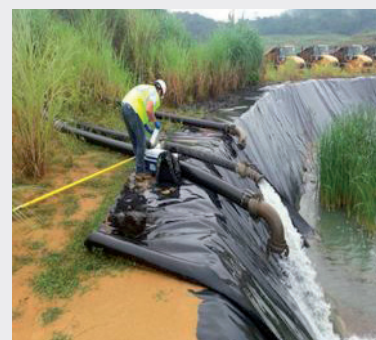
*Sampling pool effluent.*

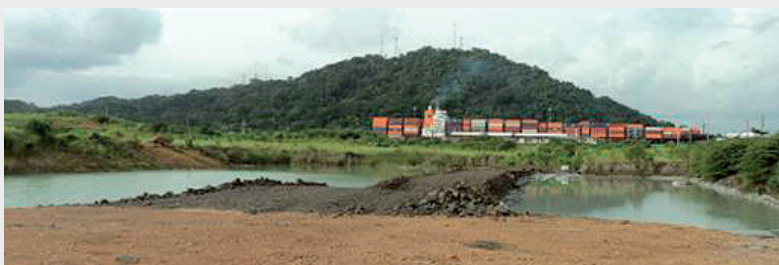
*Division of the pool - the central dyke acts as a filter.*

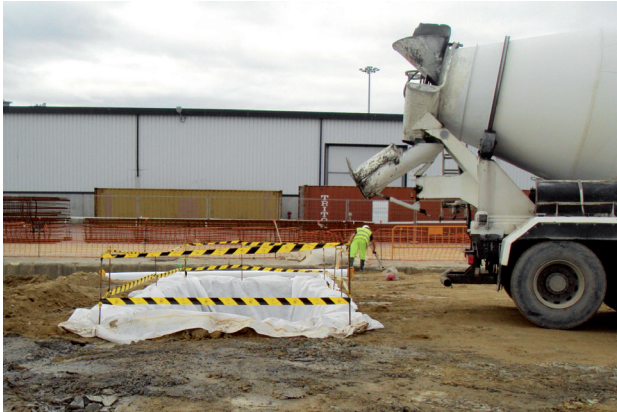
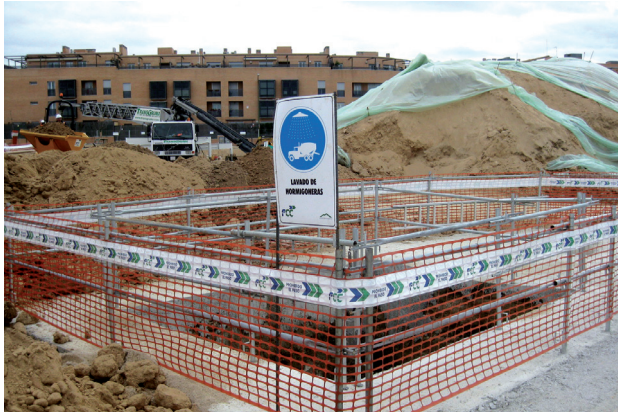
> Example of two Good Practices related to discharges, which were implemented in the construction of Vigo New Station. Firstly, a temporary barrier using bales of straw was erected to prevent an increase in turbidity in nearby water courses and, secondly, the channelling of water used for rinsing concrete mixer gutters into a specially designed purpose-built pool before discharging it into the surrounding area.

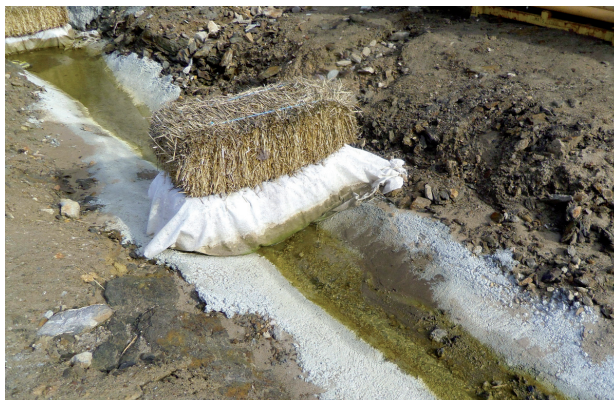
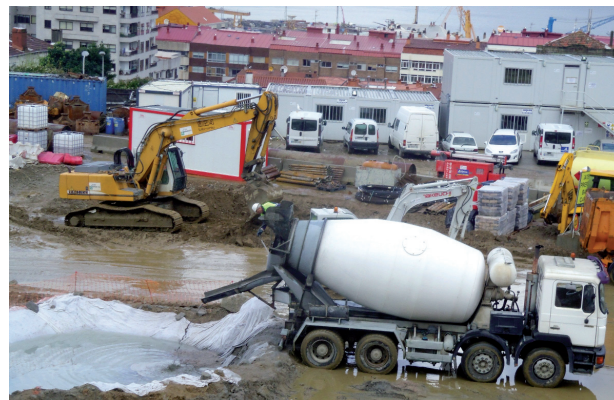
➤ Example of two Good Practices related to discharges, which were implemented in the construction of Vigo New Station. Firstly, a temporary barrier using bales of straw was erected to prevent an increase in turbidity in nearby water courses and, secondly, the channelling of water used for rinsing concrete mixer gutters into a specially designed purpose-built pool before discharging it into the surrounding area.

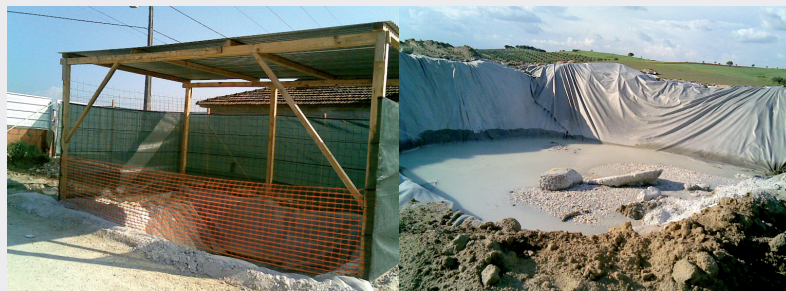
Concrete washing pools.

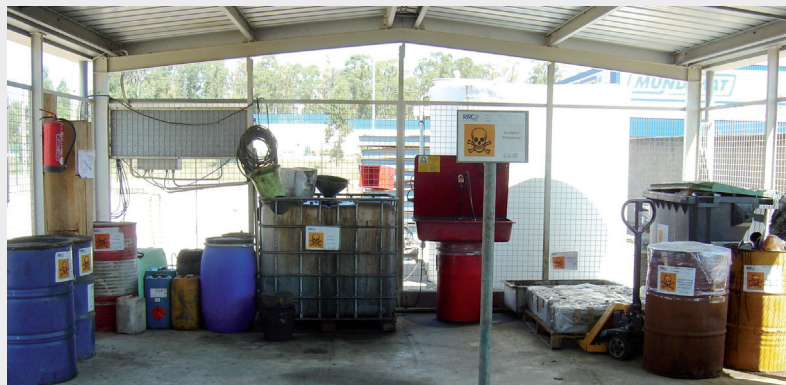
Storage of hazardous substances and waste.

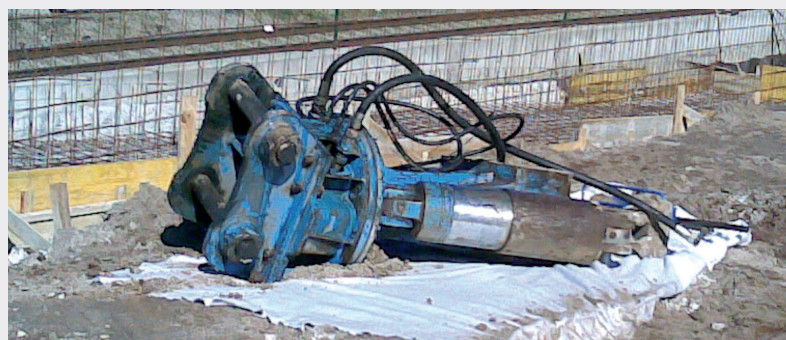
Protection of the ground on which equipment and machinery are parked.

In addition to the maintenance of the vehicles and equipment in waterproofed areas, it was also ensured that the equipment or component parts thereof that could cause possible contamination of the soil with oils or gasoil would always be stored in waterproofed zones.

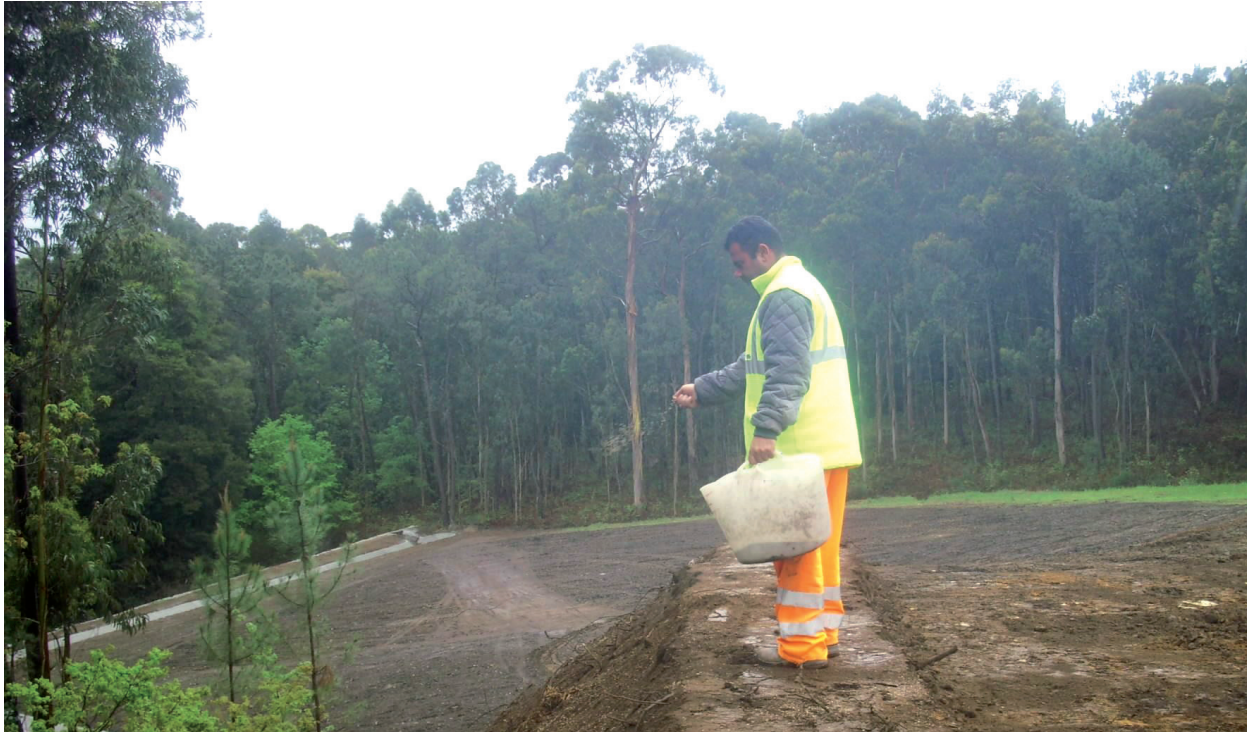
➤ The restoration of the areas affected using the means available on the site is a Good Practice that counter-acts environmental risks of land-use, visual impact of the works on the surrounding landscape and loss of the potential uses of the land on which the building or infrastructure is being constructed.

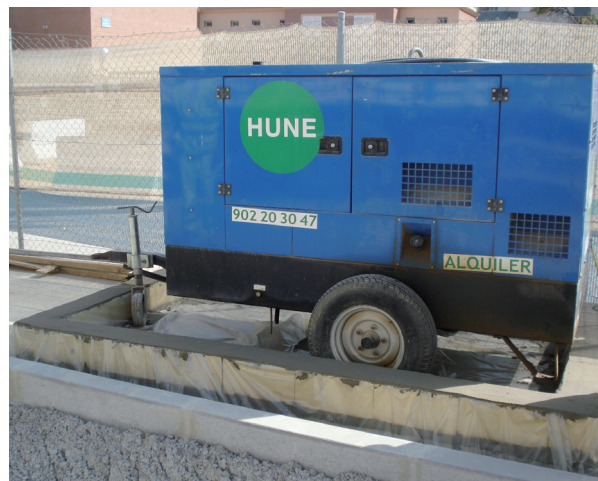
➤ To prevent harm from accidental discharges of fuel, oils or other hazardous substances, we waterproof the surface where the machinery used on site is located, such as the generator in the picture.

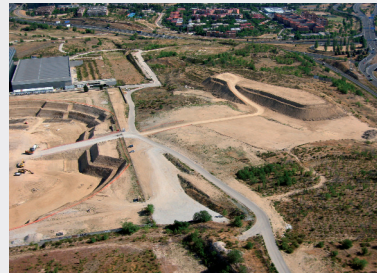
On the left, a panoramic view of the site; on the right, stockpiles of earth.

Although at that date the football pitch and access tunnels had not yet been excavated (approximately 230,000 m<sup>3</sup>), the manner in which the excavated soil has been managed thus far is evidence of the good environmental performance of the project.

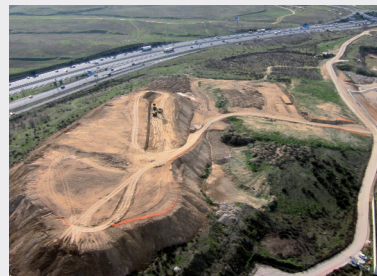
Machinery excavating earth for the foundation landfills.

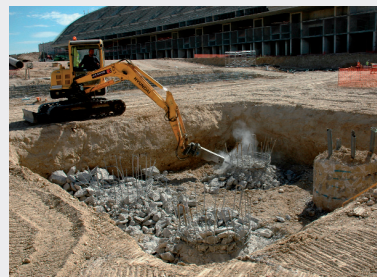
The initial project involved digging a trench for each pile head, which made the pile head stripping and steelwork tasks, and the formwork for them more difficult.

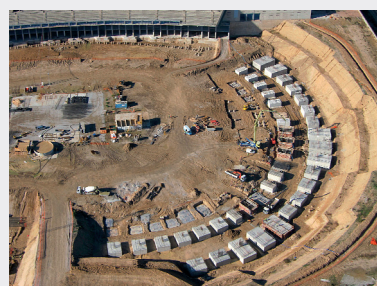
The definitive solution for fitting the foundation pile was to dig a trench to ensure that the work could be executed correctly.

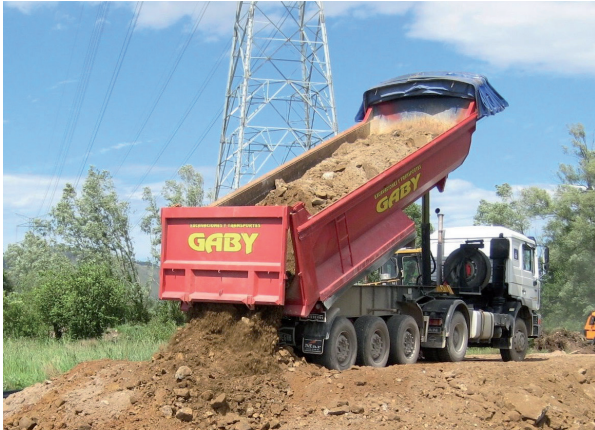
> A Good Practice to reduce the volume of soil to landfill is to stockpile earth and uncontaminated materials for later use for filling in the same project. In this way, we modify the use originally planned for this material; reducing the need for space associated with landfill sites and minimising the consumption of material from borrow pits.

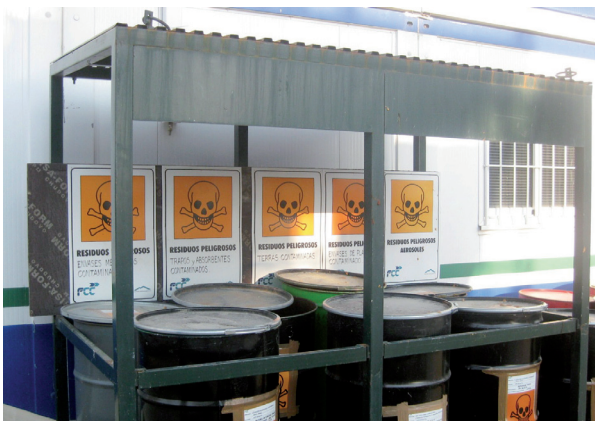
> FCC Construcción encourages and values the use of recovered items from other works, as in the case of waste storage vats, which, after completion of a project are stored temporarily and re-used in a new project.

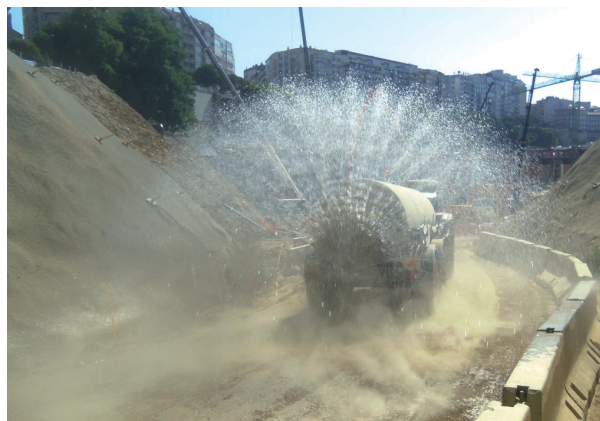
> Aware that water is a scarce resource of which we must make a rational use, in many of our works recycled water is used for spraying roads and stockpiles, provided it meets the necessary quality requirements.

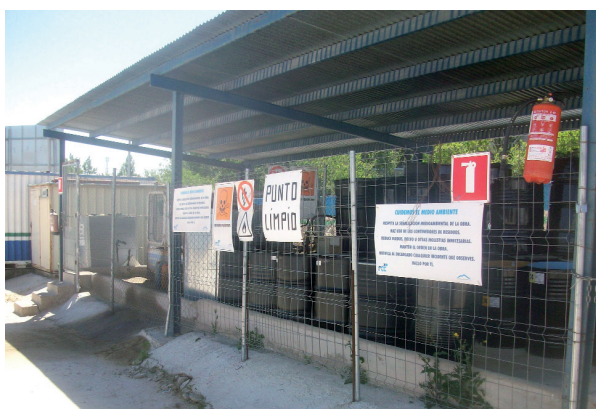
► The containers for the storage of hazardous substances and waste must be clearly identified with the appropriate symbol and label.

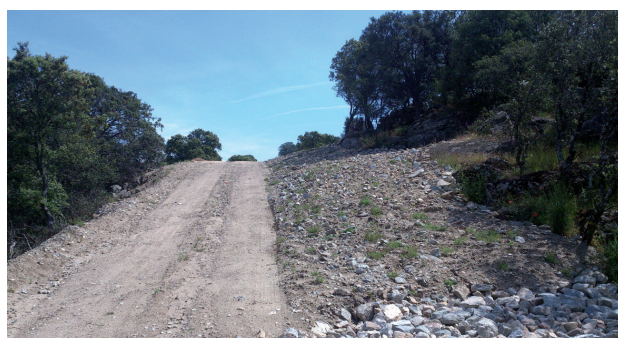
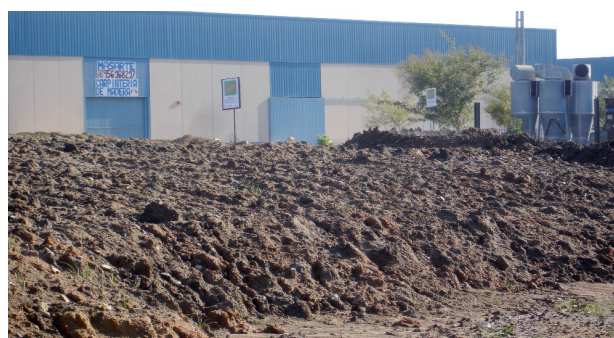
► The reuse of surplus materials such as earth and rocks, preferably by the same project that generates them, or in another project, means that waste can be converted into useful material to complete other phases of the works projects. As well as reducing the volume of waste sent to landfill, this means that natural resources can be spared.

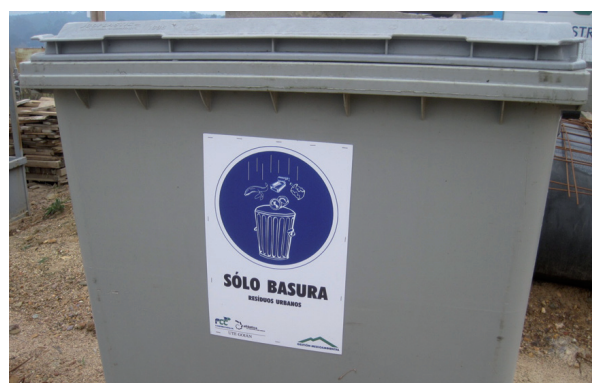
➤ The signposting of the waste storage areas, especially if it is graphical signalling, increases the understanding of the project personnel, regardless of their nationality; what improves the organisation and cleanliness of the working place.

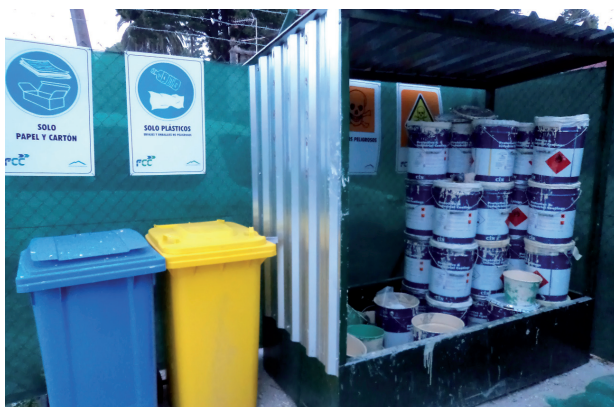
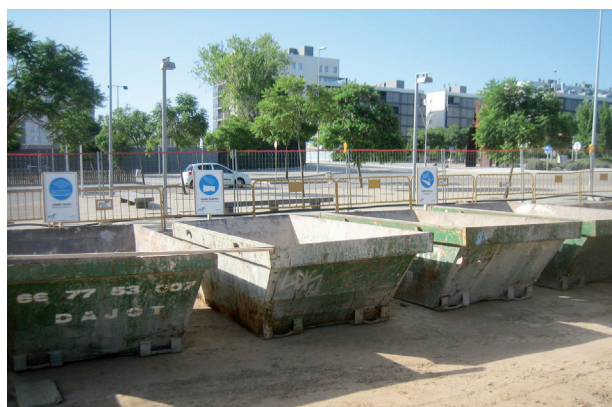
► The control and suitability of waste storage areas are crucial for correct waste management.

This is why all works have areas specifically designed for storing waste properly and safely, whether it is the result of the activities or generated by subcontractors.

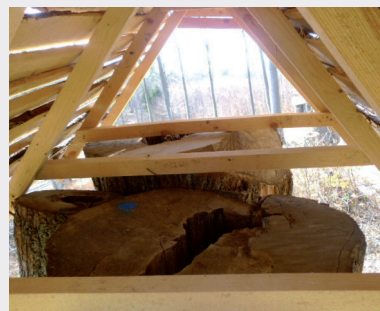
Lashing the trunks together to make a den.

- Throughout the winter, shelters for the transfer of the larvae to their natural habitat in spring were created. To achieve this, the tree trunks that had been cut after removal of the larvae were cleaned and cured with natural materials, in the unlikely event of the trunk having been damaged in the extraction process. The 27 tree trunks that were treated in this manner were lashed together 3 x 3 to form 9 dens. The trunks were then buried at a depth of one metre and at the base stones, soil, arid material, plant

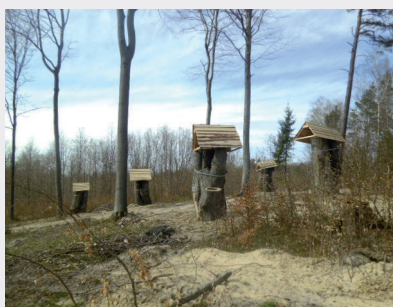
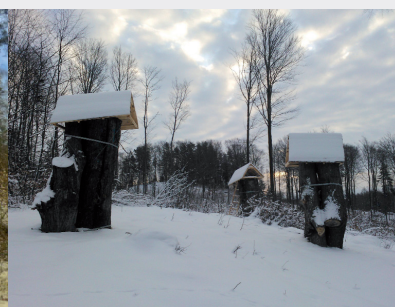
Constructed dens in which the larvae were placed at the end of the winter.

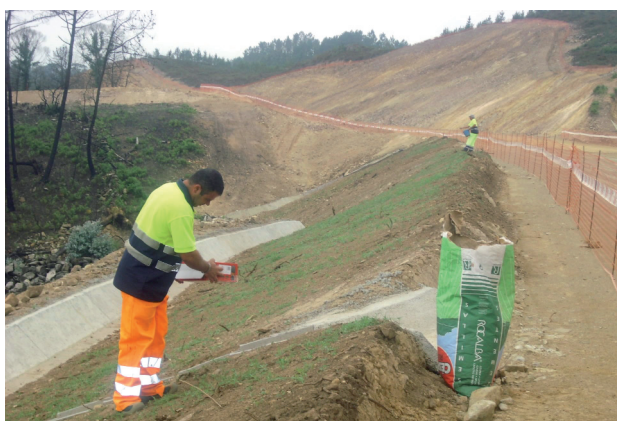
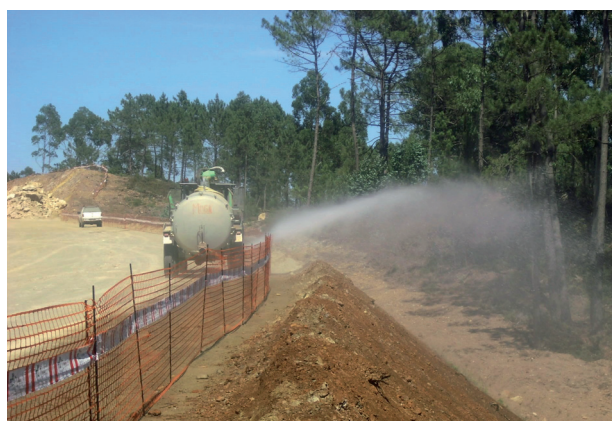
> In order to integrate sites where construction works into the surrounding landscape, re-landscaping operations are conducted. For instance, measures were employed such as hydroseeding, which enables cuttings to be replanted.

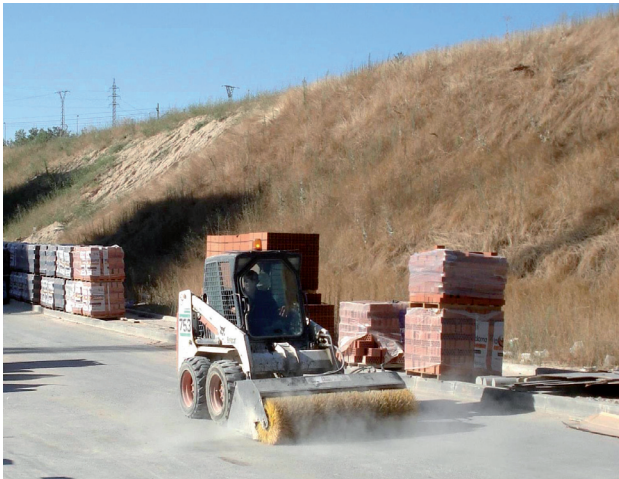
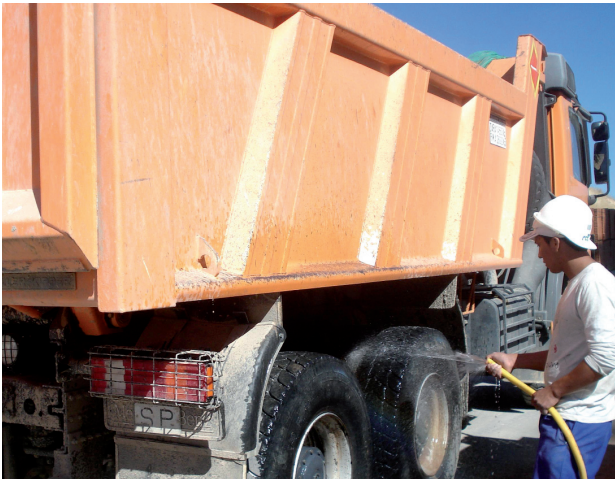
> To minimise the inconvenience caused by our operations and prevent soiling of roads from the works, actions such as the use of sweeping or washing the wheels of trucks before going on to public roads are carried out.

ciated with construction sites. Thus, in 79% of our construction projects truck wheels were sprayed before they ventured onto the public highway. Likewise, to minimise the nuisance occasioned by occupying pedestrian areas and link roads to the site's facilities, protective measures were taken on 56% of sites (fencing, signposting, cordoning off the pavement, road surface etc.) and alternative access routes were provided.
